# Manhole Inspection Summary

Manhole # S31EE\_005MH

Insp Date: **1/26/07 11:39 AM**

**Location** Address: **29TH DIVISION ST**

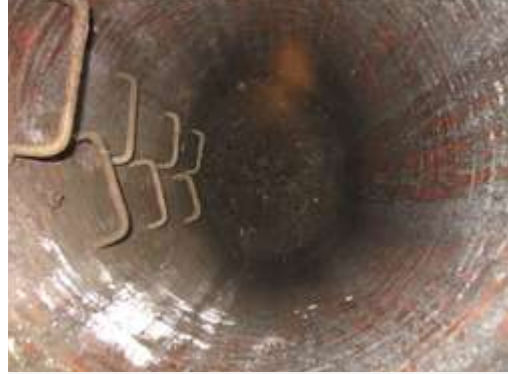
Top View

Corroded steps. Channel debris.

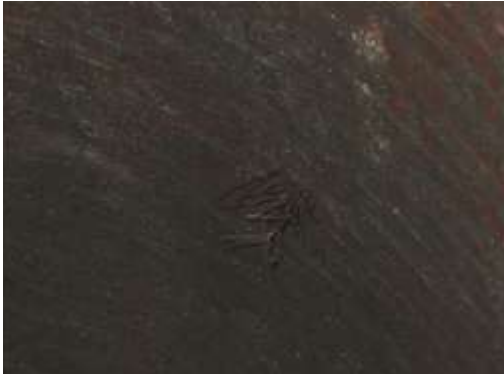
Defect

Barrel root intrusion and infiltration.

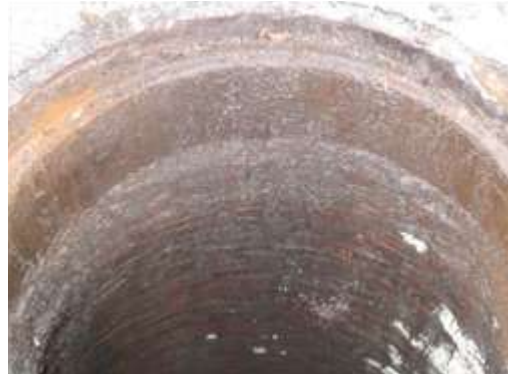
Defect

Frame leaks. Adjustment infiltration.

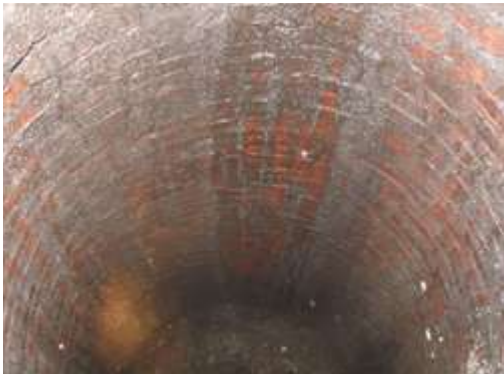
Defect

Adjustment and Barrel infiltration.

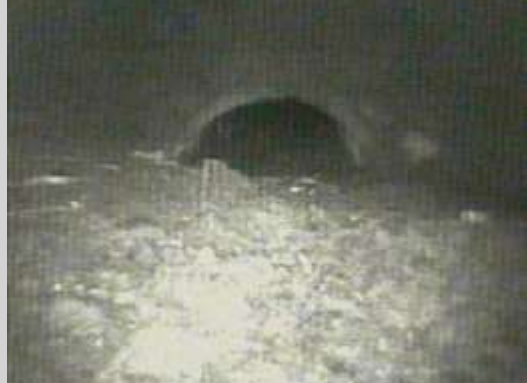
8 in. Circular Gravity Sewer  
Pipe Out @ 12 O'Clock

Deposits: ☐ None ☒ **Mud** ☐ Sludge ☒ **Debris** ☐ Grease

Silt Depth: **3** (in.) Deposits Extent: **Medium**
